Manhole Inspection Summary

Manhole # S19I1_021MH

Location Address: **2422 hariett av**

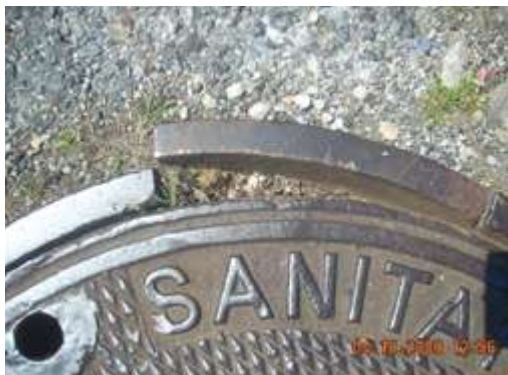
Defect 5

☒ **Leaks**

cover leaks

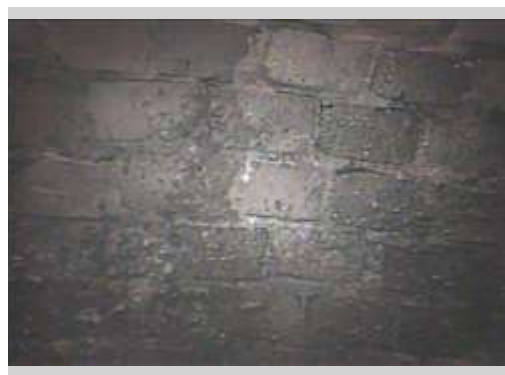
Defect 4

Infiltration: ☐ None ☐ Joint ☐ Cracks ☐ Mortar ☐ Roots ☒ **Wall**

infiltration @ barrel wall

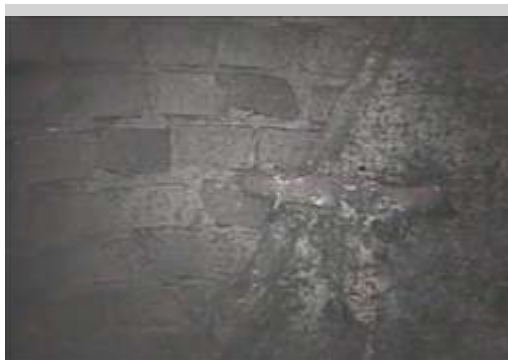
Defect 3

☒ **Evidence Of Surcharge**

Depth: **6** (ft.) ☐ Active Surcharge Present

surcharge evidence

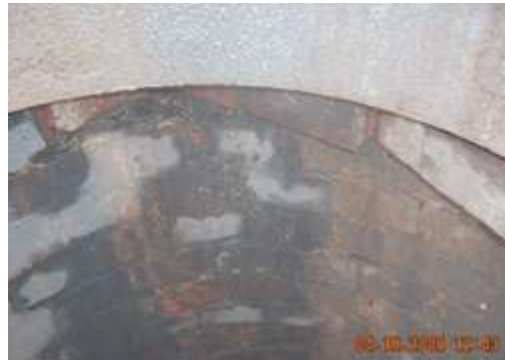
Defect 6

Infiltration: ☐ None ☒ **Joint** ☐ Cracks ☐ Mortar ☐ Roots ☐ Wall

infiltration @ frame/chimney joint

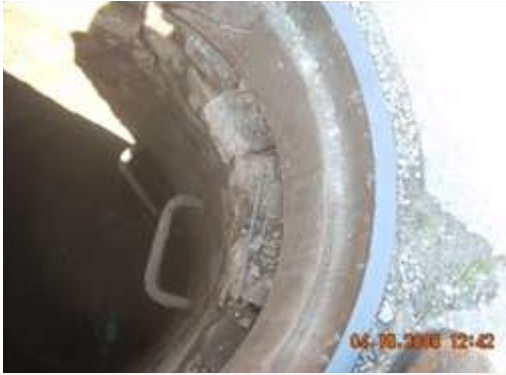
Defect 2

Offset: **3** (in.)

frame offset

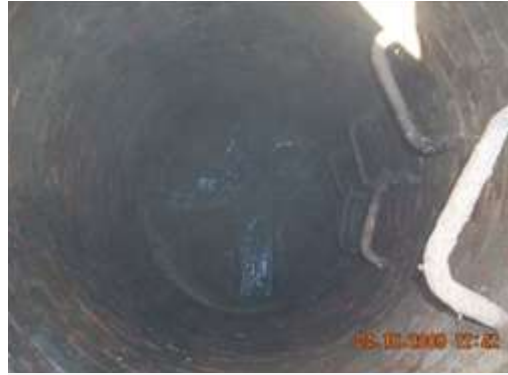
Defect 7

Condition: ☐ Sound ☐ Cracked ☐ Root Intrusion ☒ **Deteriorated** ☐ Leaks ☐ Debris

Bench condition deteriorated

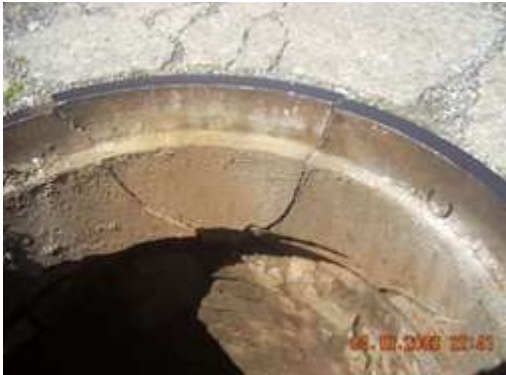
Defect 1

Condition: **Broken**

☒ **Cracked**

cracked/broken frame

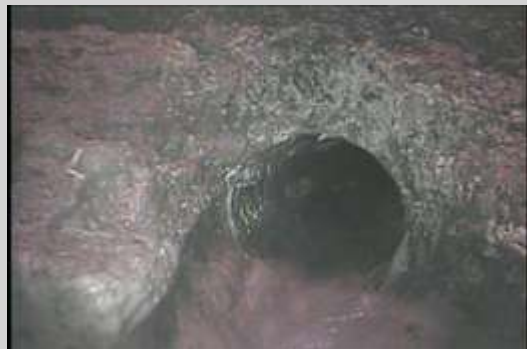
9 O'Clock Inflow

deteriorated bench
